PROJECT REFERENCE

PCI accompanies the refurbishment of the protected power line on the Predigtstuhl in Bad Reichenhall

Concrete refurbishment on the mountain

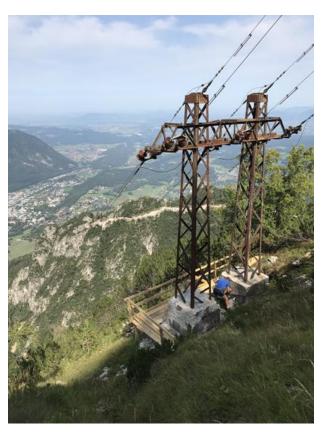
The old power line to the Predigtstuhl cable car was due for refurbishment in 2018, in the 90th anniversary year of the railway. Four tons of PCI building materials were brought to the construction site by helicopter. The first step was to remove the base concrete and remove rust from the steel. PCI Elastoprimer 220 was used as corrosion protection.

The first step in the refurbishment measure was to remove a large area of the concrete from the base and remove rust from the steel. The processor then applied the corrosion protection PCI Elastoprimer 220 as rust protection. The concrete repair was started with the help of a specially made wooden cladding. To enable the rainwater to run off, Josef Unterrainer first made a cap in the upper base area with the variable quick-setting mortar PCI Repament Multi, and a cove in the

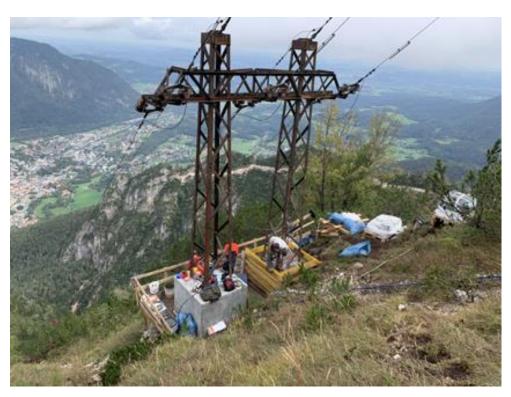
From corrosion protection to grouting, only PCI building materials were used. PCI specialist advisor Marcus Donhauser and PCI service technician Jürgen Linke were on site.

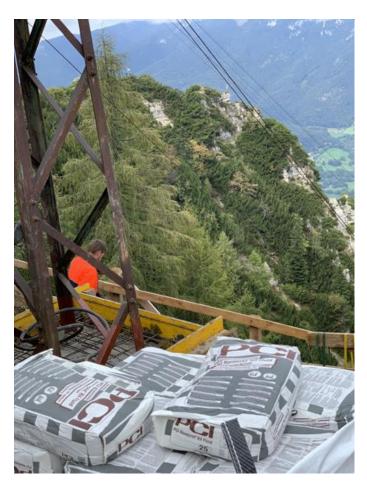
For permanent protection, the processor made a cap with PCI Repament Multi in the upper area and a cove fillet with PCI Polyfix plus L in the lower area of the base. PCI Nanocret R4 Fluid was already ready for grouting.

lower area. He used PCI Polyfix plus L. The quick-setting cement mortar sets quickly and cures without cracks after around 25 minutes. Its high compressive and flexural strength enables safe and stable anchoring. Fast-setting and, at the same time, particularly reliable building materials were decisive for this construction site due to the high demands and the imminent onset of winter.

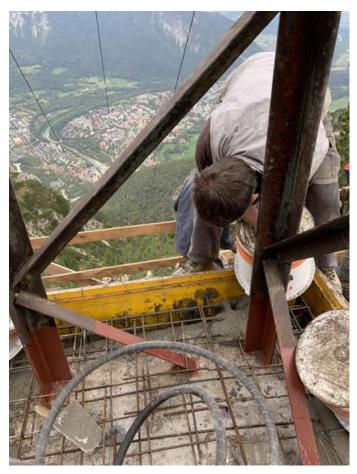
Construction site at lofty heights: After producing a wooden formwork, processor Josef Unterrainer cast the base with PCI Nanocret R4 Fluid.

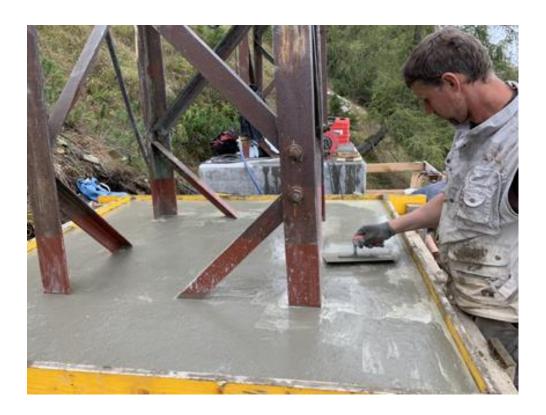
PCI Nanocret R4 Fluid withstands the highest demands.

Therefore, PCI Barraseal Turbo was used for waterproofing the base. The flexible mineral waterproofing slurry sets quickly and waterproofs concrete parts permanently and reliably. PCI Barraseal Turbo meets all requirements as a surface protection system of class OS5b according to RiLi-SIB. Josef Unterrainer used PCI Nanocret R4 Fluid to cast the base: The high-strength repair mortar offers long-term security even under extreme stress. Due to its self-compacting flow behavior, filling spaces can be closed in a non-positive manner and free of defects.

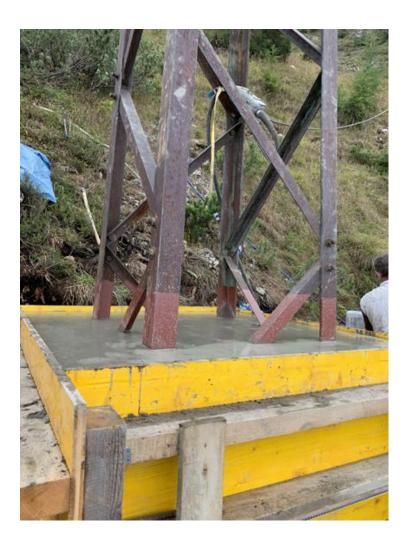
Perfectly refurbished: The PCI products protect the base of the old power line on the Predigtstuhl permanently from the weather and moisture.
